Manhole Inspection Summary

Manhole # S23GG1028MH

Inspection ☐ Is Incomplete Rating: **4) Poor**

Location Address: **1441 MEDFIELD AVE**

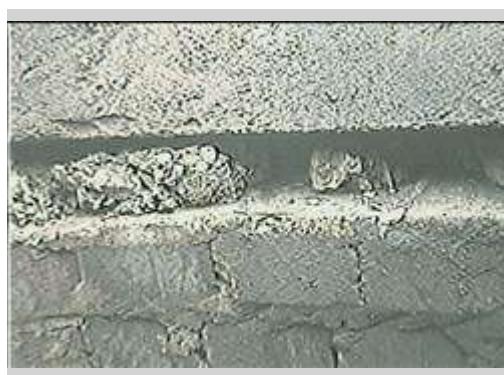
Defect

☒ **Leaks**

Condition: ☐ Sound ☐ Cracked ☐ Root Intrusion ☒ **Loose Brick** ☒ **Deteriorated**

Infiltration: ☐ None ☒ **Joint** ☐ Cracks ☒ **Mortar** ☐ Roots ☐ Wall

Frame leaks. Adjustment deterioration, loose brick and infiltration.
